Framing Failures in Wood-Frame Hip Roofs under Extreme Wind Loads

Sarah A. Stevenson¹, Gregory A. Kopp^{1*} and Ayman M. El Ansary²

Wood-frame residential roof failures are among the most common and expensive types of wind damage. Hip roofs are commonly understood to be more resilient during extreme wind in relation to gable roofs. However, inspection of damage survey data from recent tornadoes has revealed a previously unstudied failure mode in which hip roofs suffer partial failure of the framing structure. In the current study, evidence of partial framing failures and statistics of their occurrence are explored and discussed, while the common roof design and construction practice are reviewed. Two-dimensional finite element models are developed to estimate the element-level load effects on hip roof trusses and stick-frame components. The likelihood of failure in each member is defined based on relative demand-to-capacity ratios. Trussed and stick-frame structures are compared to assess the relative performance of the two types of construction. The present analyses verify the common understanding that toenailed roof-to-wall connections are likely to be the most vulnerable eleme

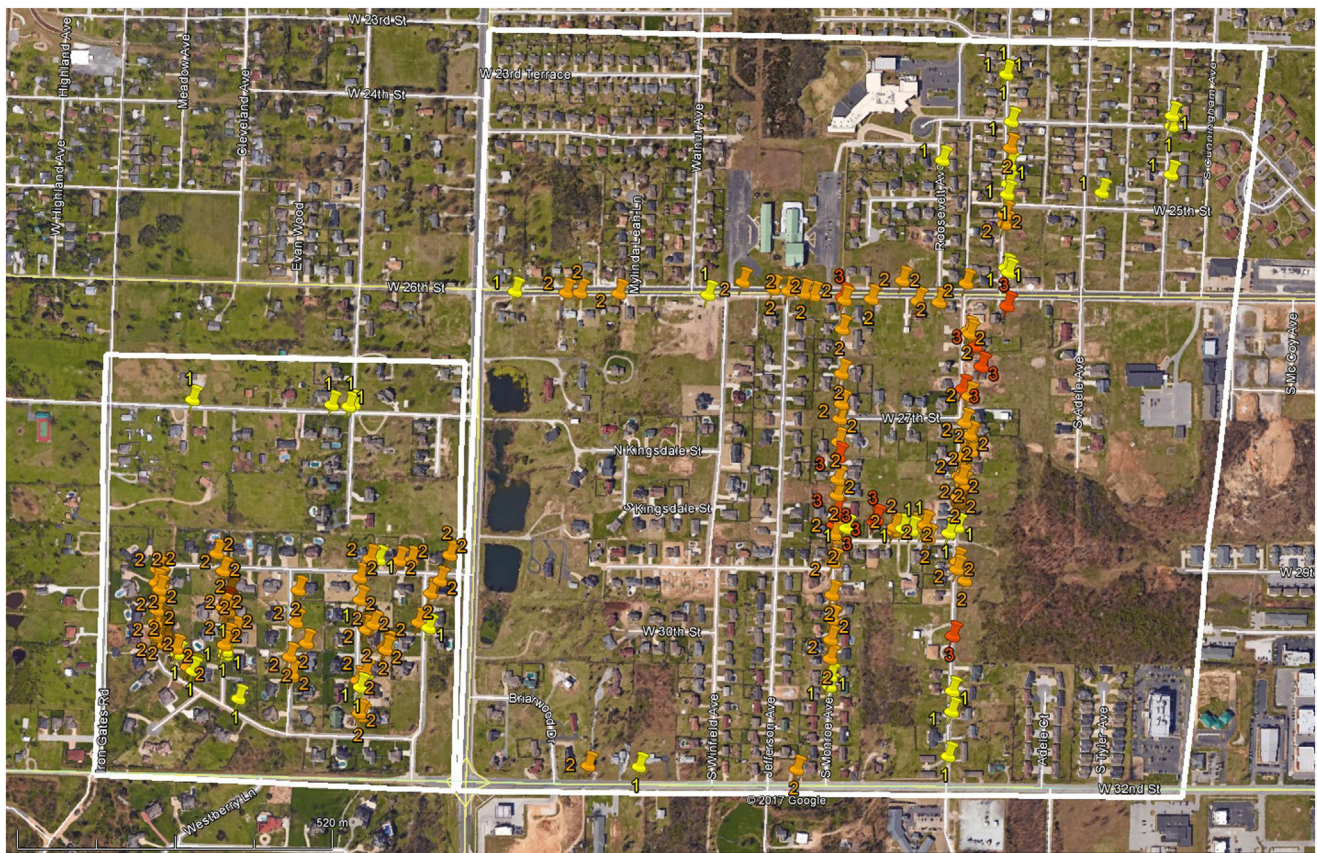
Two study areas, outlined in white on **Figure 4**, are analyzed and the occurrence of different failure modes is assessed. The damage photos at the marked locations were inspected and the perceived mode of failure is noted. In this pass through the data, each separate residence was assessed as to whether the damage appeared to be RTWC, sheathing, or framing failure. Beyond roof damage, wall failures corresponding to DOD-7 are included. The study areas were selected based on the characteristics of the houses. Historical imagery from Google Earth is used to identify the original shape of the studied roofs. Region 1, on the left side of **Figure 4**, is found to contain houses that appeared to be newer, most with steep-sloping hip roofs and large building footprints. The homes in Region 2 mostly appear to be older, masonry homes with shallow wood-framed roofs.

FIGURE 4 | West end of tornado damage path following the May 22, 2011 tornado in Joplin, MO; the present study regions are outlined in white.
